FIVE-YEAR REVIEW REPORT FOR ACE SERVICES SUPERFUND SITE THOMAS COUNTY, KANSAS

U.S. Environmental Protection Agency Region 7 Lenexa, Kansas

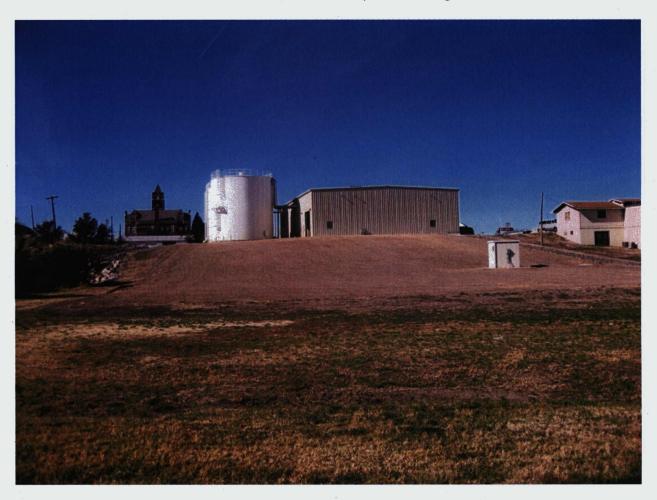
Ace Services – Groundwater Treatment Plant, tanks and cap area, looking west

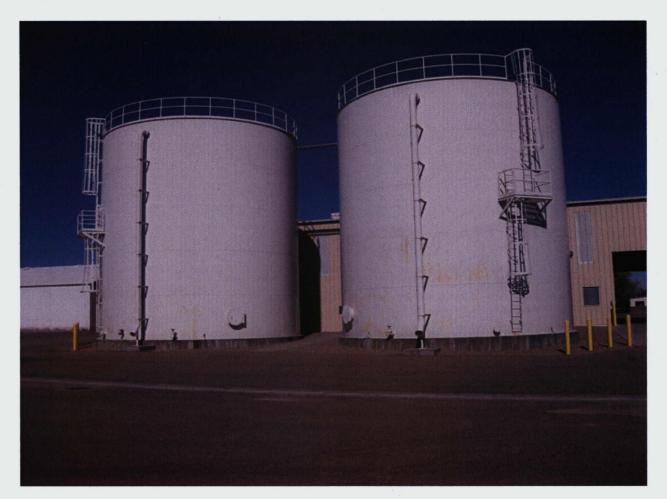
Ace Services – Influent and Effluent Tanks

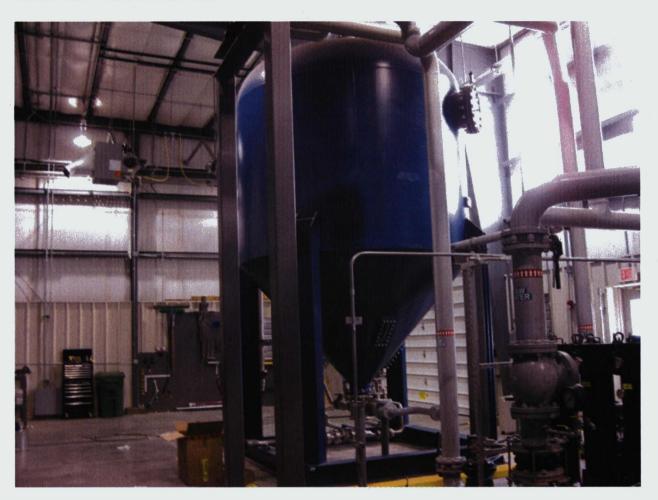
Ace Services – Resin transfer vessel

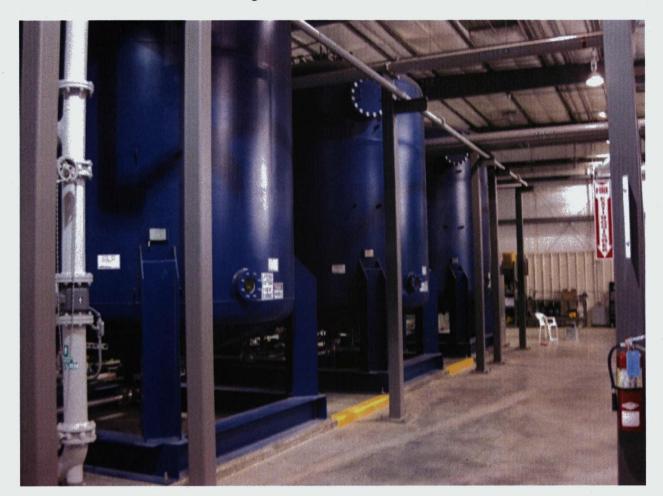
Ace Services – Train B south side looking east
